2015 Subaru WRX F4-2.0L DOHC Turbo

PITCHING STOPPER BRACKET DESIGN CHANGE

NUMBER: 12-210-17

SUBJECT: Pitching Stopper Bracket Design Change

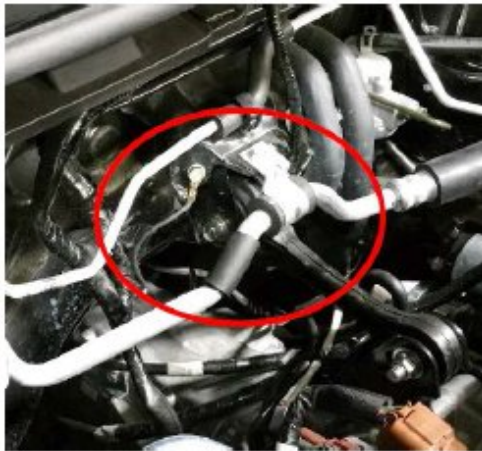
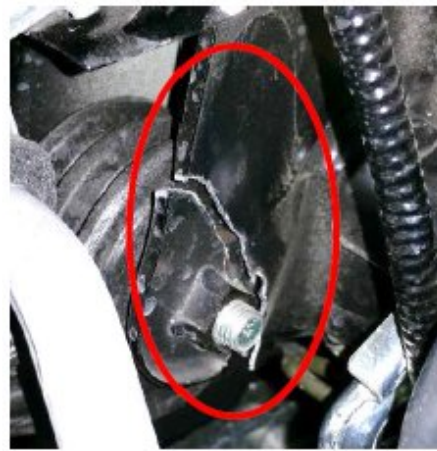
The following information outlines a procedure for replacing the pitching stopper bracket on 2015-2017 WRX models. The specific condition involves cracking or breakage of the pitching stopper bracket as shown below. If verified, the bracket must be replaced following the procedure below.

VERY IMPORTANT: This repair involves welding procedures and paint refinishing work to be performed outside the vehicle cabin. If a failure (as shown in the Introduction) or cracking of the pitching stopper bracket is confirmed, it **MUST** be replaced. Unless your Service Department has their own in-house Body Shop, these repairs must be sublet to a certified Body Shop who will be better suited to handle this type of repair. It cannot be over-emphasized that any and all of the proper precautions to protect the exterior and interior of the vehicle **MUST** be taken. From grinding sparks generated during the preparation steps to actual welding-related hazards like (but not limited to) sparks, hot weld spatter, and paint over-spray, it is imperative every precaution is taken to protect the windshield glass and surrounding painted surfaces from these hazards as they can easily be damaged if left uncovered.

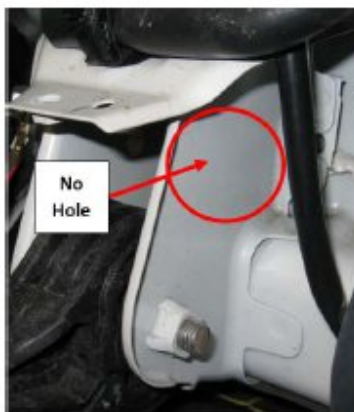
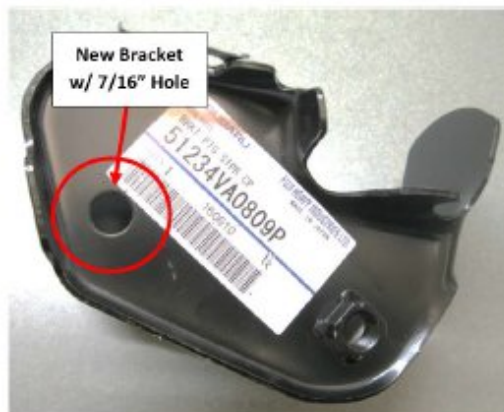
The part number for the new pitching Stopper bracket is: **51234VA0809P**. The new bracket is easily identified as the thickness of the material used has been changed from 1mm to 2mm. There is also a 7/16" hole near the top on the driver's side of the bracket above the weld nut for identification.
