## SERVICE BULLETIN

**APPLICABILITY:** 2012-14MY WRX Models (EXCEPT STI)  
2012-13MY Forester Turbo

**NUMBER:** 07-96-15  
**DATE:** 08/10/15

**SUBJECT:** Design Change to Engine Wiring Harness

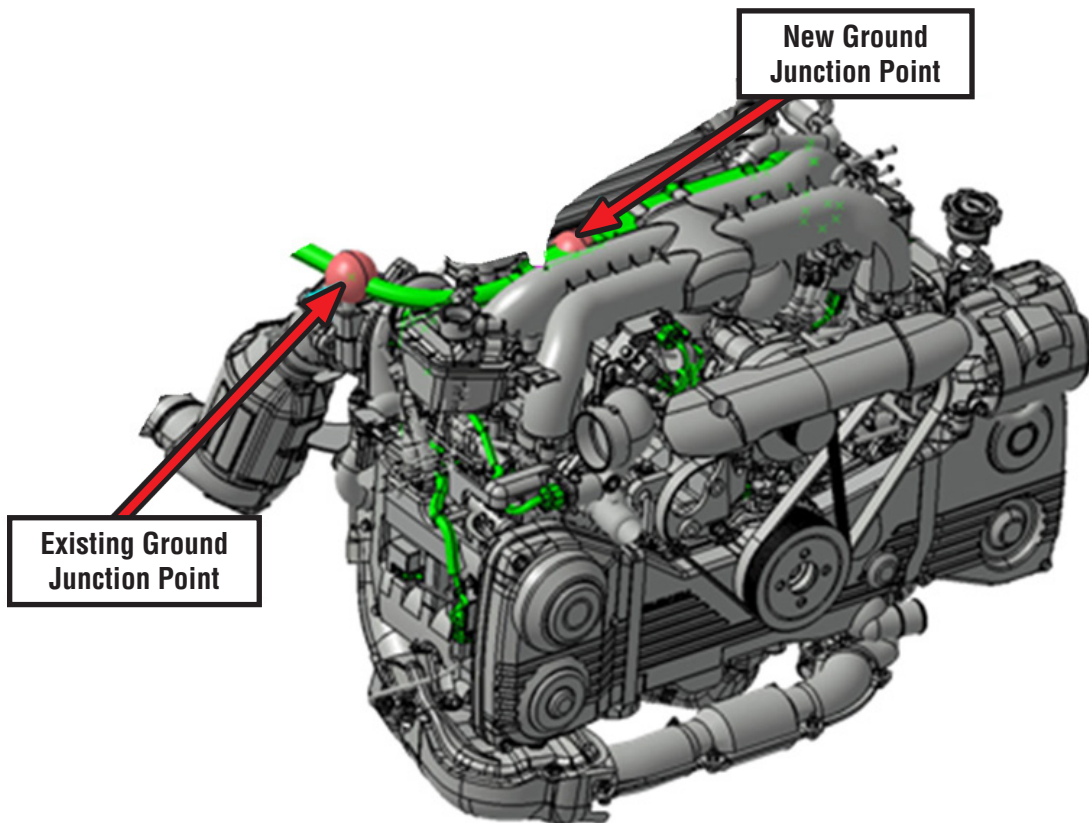
This Service Information bulletin reviews a design change to the engine wiring harness to eliminate improper diagnosis of the Evaporative Leak Check Module (ELCM) by the ECM which could set Diagnostic Trouble Code (DTC) P0451 in error. Some examples of other DTCs affected by this harness change are: P0068, P0452, P0453, P0107, P0108 and P0300. The change involves a repositioning of the sensor and actuator wiring ground junction point to a location unaffected by engine movement and high temperatures (near turbocharger) which may develop excessive resistance. Since this condition develops over time, DTC(s) may set very intermittently with long periods of time between occurrences. A more frequent occurrence of any of these DTC(s) may indicate a different root cause other than the condition described in this bulletin.

DESCRIPTION	PART NUMBER	APPLICABILITY
HARNESS-ENGINE	24020AF071	2012MY WRX & Forester Turbo
	24020AF531	2013-14MY WRX & Forester Turbo

- Always follow the diagnostic procedure in the applicable Service Manual for the DTC(s) being diagnosed. The example DTCs listed in the Introduction section all involve components and sensors located on or near the intake manifold (e.g. intake manifold pressure sensor). They all supply ECM inputs and utilize the referenced common ground point. Any increase in resistance to ground can have significant effect on these sensor outputs to the ECM and cause DTC(s) to set.
- When replacing the engine wiring harness, the service procedure remains unchanged.
