Service Bulletin Update - Intake Valve Cleaning

This update is a brief summary explaining how to clean the intake valves on a L3T Mazda DISI engine. This particular engine has just over 30,000 miles on it and has used only premium grade 93 octane fuel along with fully synthetic oil. The vehicle's EGR was deleted at 24,000 miles. The decision was made to clean the valves to get this motor into peak performing condition so we could use the vehicle as a COBB Tuning test vehicle. We also wanted to test our theories to see what role the condition of the intake valves have on the vehicle's performance.

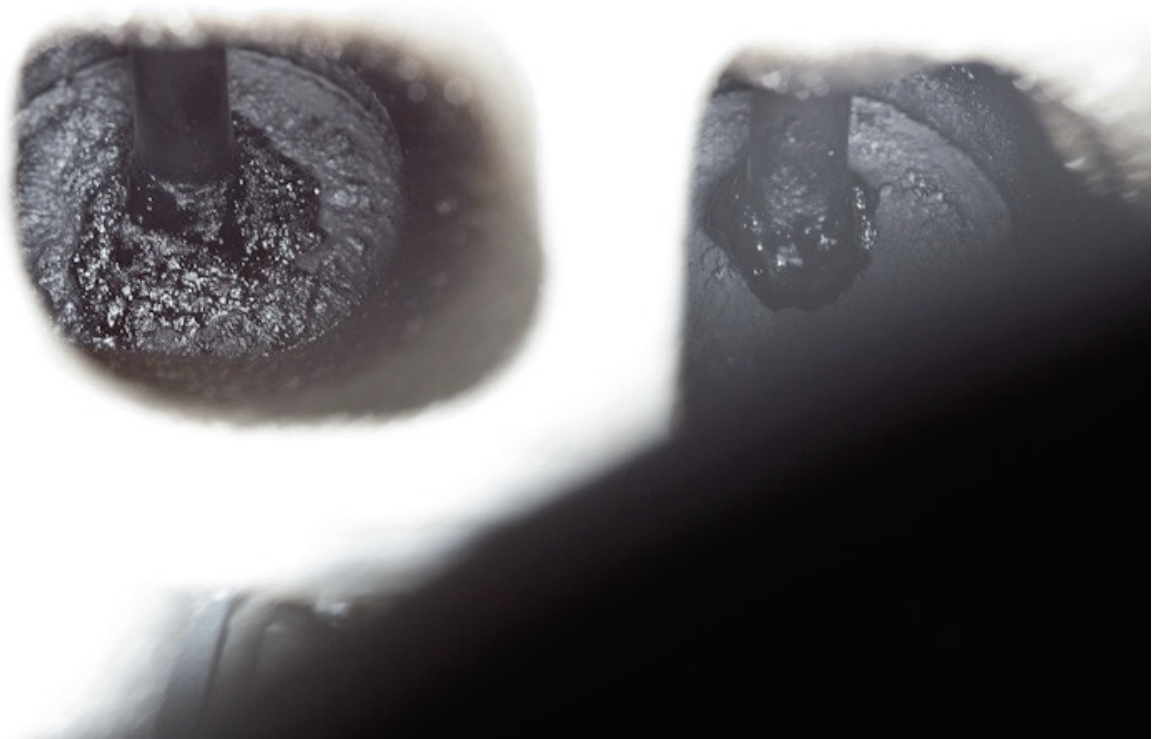
Cylinder #4

These pictures represent cylinder #s 4-2, starting at driver's side of the car and working to the passenger side, where the timing chain is located. Although, as you can see, the intake valves

for the cylinder closest to the Exhaust Gas Recirculation (EGR) port, pictured above, have the greatest amount of carbon build up. This carbon build up is more common with DISI engines since a fuel injector is no longer located in the port, firing above the intake valves in order to help wash the carbon off of the valves. It can be assumed that the closer in proximity to the return for the EGR system, the greater carbon build up on the intake valves will occur.

The valves in this port were the only of the 8 individual ports on the vehicle that showed a thick, gooey type of carbon build up as opposed to a dried/charred looking carbon build up exhibited on the intake valves of the other three cylinders.

To clean the valves, a variety of solvents were tested. Each solvent was allowed to soak for 15 minutes inside the port before any brushing or physical cleaning took part. The following were our impressions as to how each solvent interacted with the carbon buildup on the valves.

While we did not capture any “during” photos taken of each valve after their initial soakings; in the end, all the valve ports received at least 15-20 minutes of vigorous picking, scraping, and scrubbing with a combination of all the solvents. Please be sure to not scratch the valve shaft surfaces too far above the valve head as this is where the valves glide inside the valve seals and a scratched valve shaft surface may cause premature wear of the valve seal. This caution also goes for the bottom of the valve head where the precise machining to match the valve seat takes place.

To physically clean the valves, we used a combination of gun cleaning tools, consisting of various picks and wire brushes to agitate and remove the carbon buildup. The pick tool comes in handy when attempting to remove buildup on the back side of the valve. Some bending/flattening of your tools may be necessary to better accommodate the job.

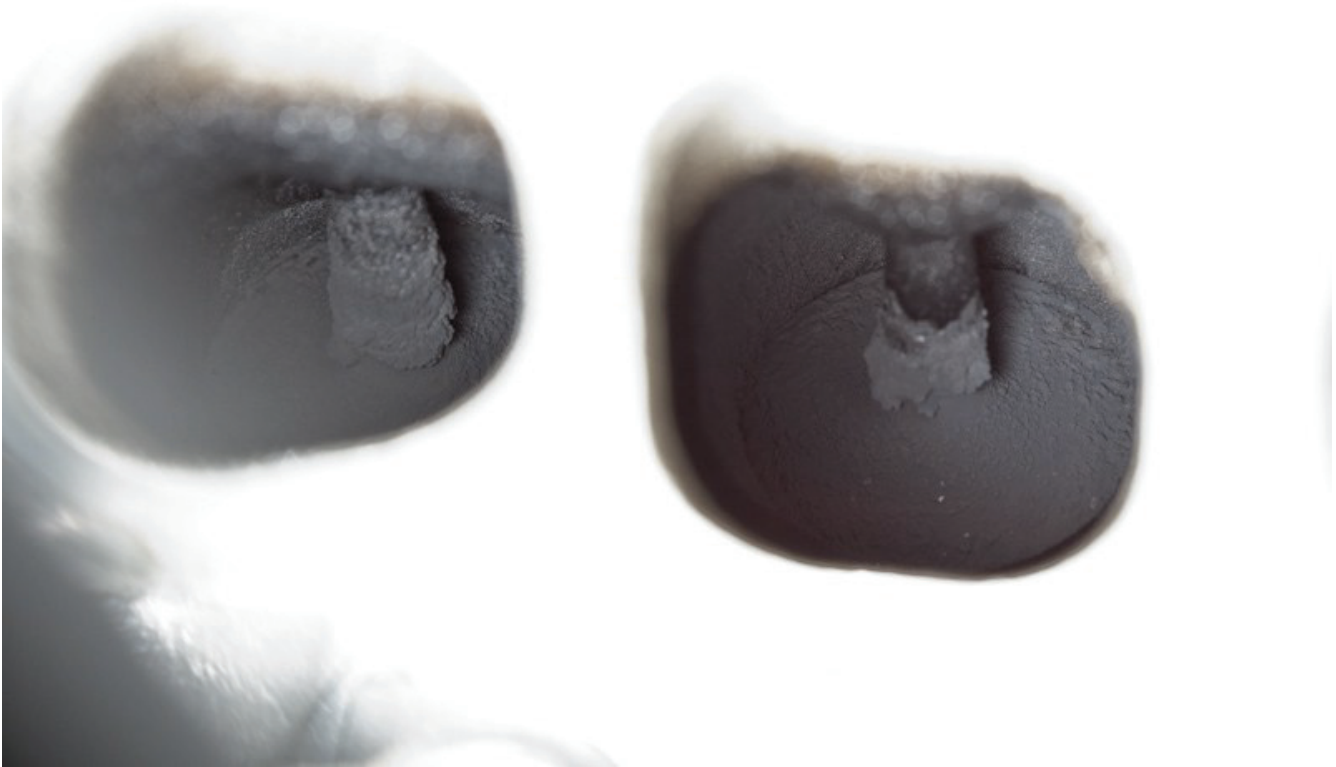
Cylinder #3

Less gooey carbon is present on the intake valves for this cylinder, but the carbon build up is still significant and unexpected for such low mileage.

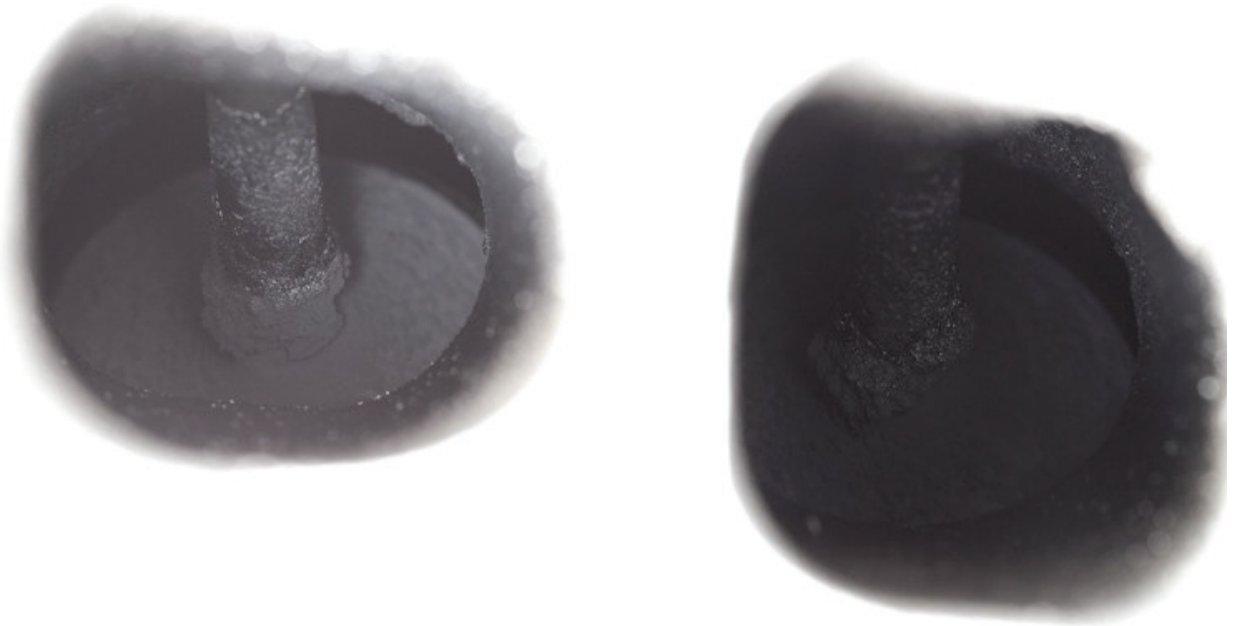
Cylinder #2

Unfortunately, we managed to not capture a picture of the #1 cylinder before the cleaning. As we mentioned, the carbon build up was less intense on the cylinders that are located further away from the EGR return.

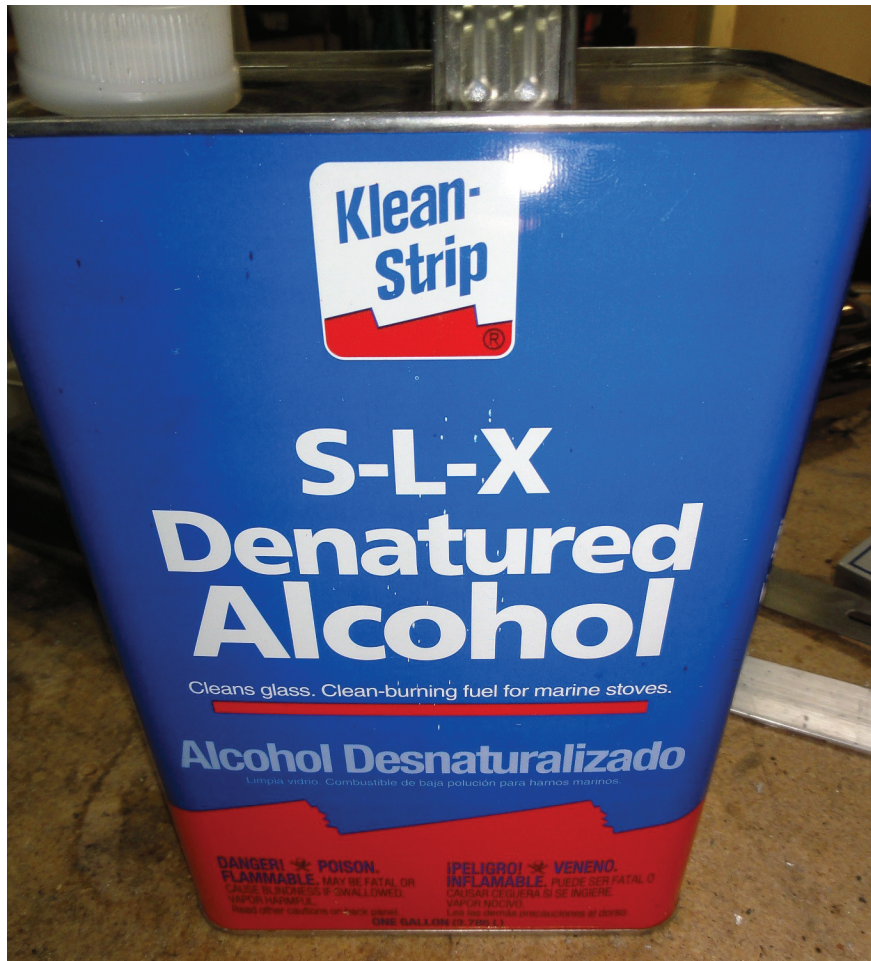
I. Denatured Alcohol - Had the strongest effect on the buildup and did the best job in turning the solution inside the port into a homogenous liquid saturated with the carbon build up. When scrubbed and siphoned away, the alcohol performed the best at removing the most buildup each subsequent "soak".

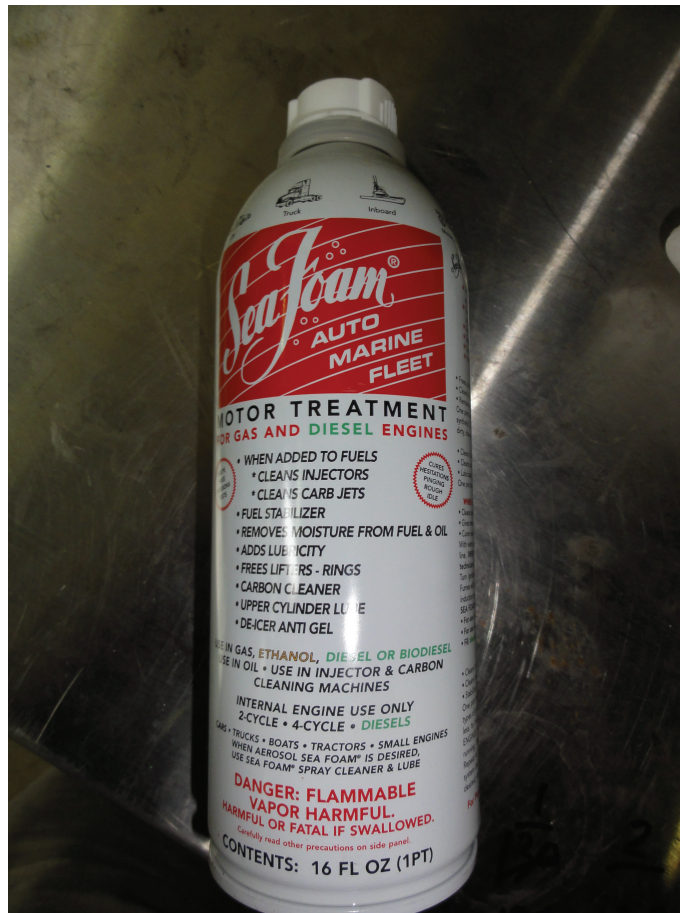
II. Sea Foam - Had a strong effect on the buildup but unlike the alcohol, did not dissolve the build up as much as it broke it down into a removable “goop” that could be scraped away and removed from the port. Unlike any other solution, the Sea Foam allowed me to scoop up material that would stick to the tools.

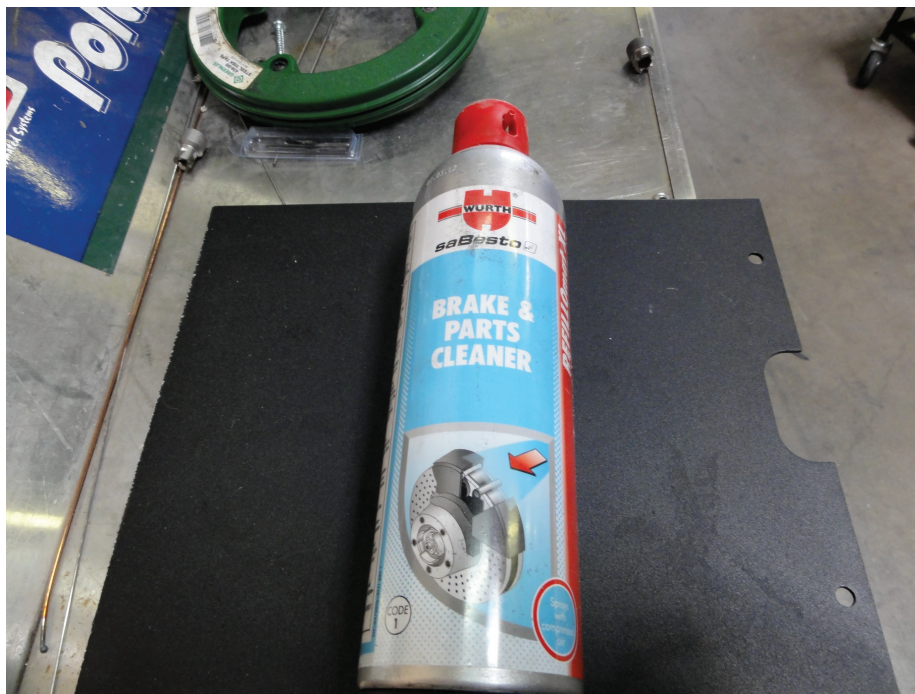
III. Brake & Parts Cleaner - While after soaking and scrubbing, the siphoned liquid from the port was obviously saturated with carbon material, the overall affect it had on the valve surfaces was

minimal compared with the alcohol and Sea Foam. The cleaning ability is similar to carburetor & choke cleaner.

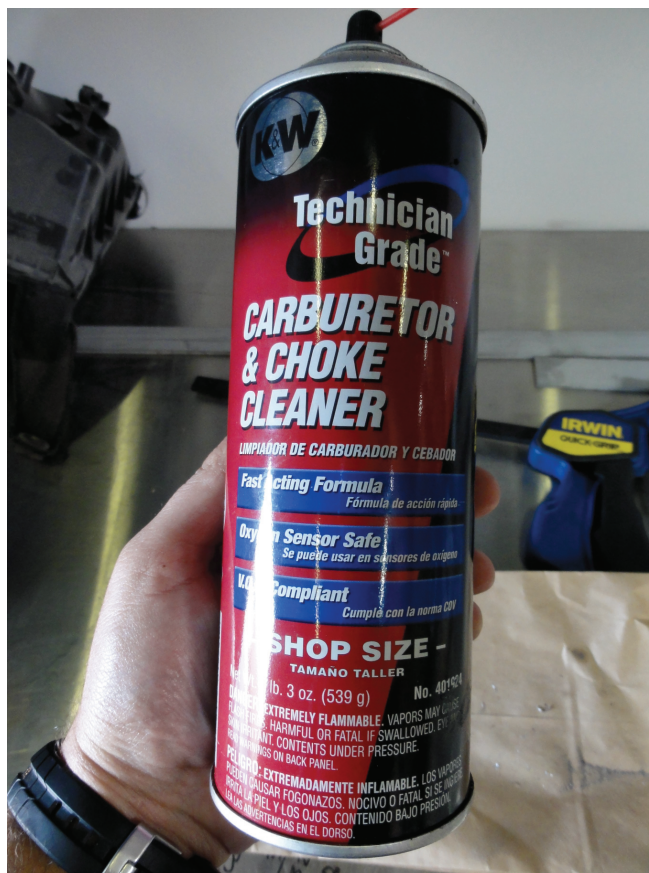
IV. Carburetor & Choke Cleaner - While after soaking and scrubbing, the siphoned liquid from the port was obviously saturated with carbon material, the overall affect it had on the valve surfaces was minimal compared with the alcohol and Sea Foam. The cleaning ability is similar to brake & parts cleaner.

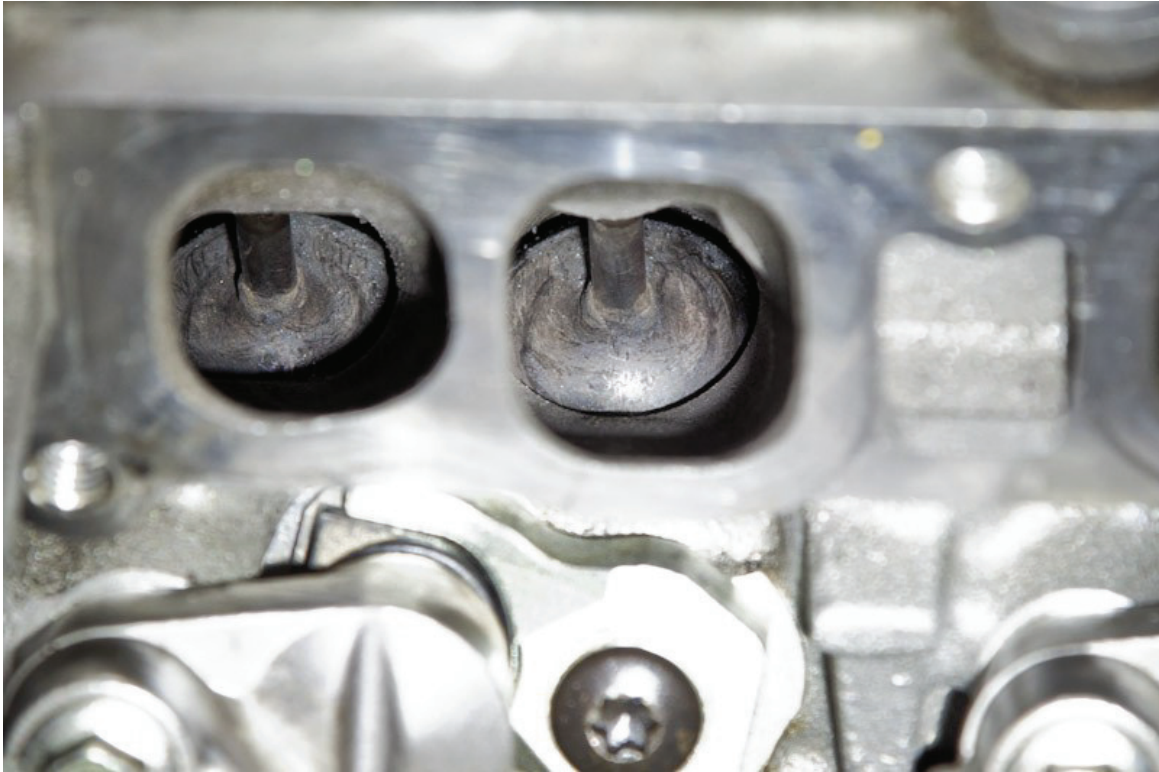
Cylinder #1 After

While in the end, the valves in no way resemble a new part, we can state that they were sufficiently clean for the task at hand. We were able to remove a large majority of the hard and soft build up on the valve surface, leaving only the most stubborn of buildup remaining. If more time had been allotted, we are confident that the remaining buildup could have been removed. Longer soak times and more diligent cleaning would also help remove the built up carbon. The more soaking and scrubbing time you a lot to this job, the cleaner the intake valves will get.

The following are pictures after the cleaning, with a better lighting than what was used on the "before" shots.

After the car was put back together and started, it was immediately noticeable that a smoother idle was achieved. We also noticed that the engine was clearly breathing better due to the +18% LTFTs that were present after the cleaning. The MAF calibration curve had already been dialed in perfectly.
